Concrete Column Repair Restores Integrity

Restoration of steel reinforced concrete columns

Concrete repair and polymer coating

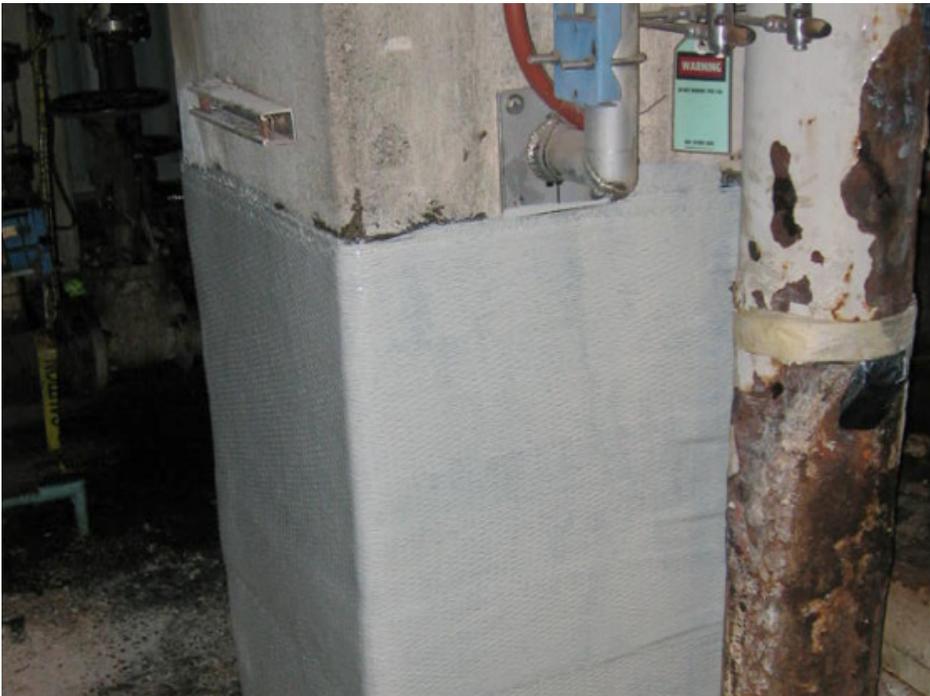
When a large pulp and paper facility discovered cracking in its primary structural columns they turned to TEAM for a quality solution to improve integrity, prevent future deterioration and provide a professional finish.

- Removal of loose concrete
- Priming of exposed repair surfaces
- Reinstatement of lost concrete with specialized repair mortar
- Overwrap of carbon fiber
- Epoxy top coat to seal repair and provide professional finish

The completed repair reinforced the structure and prevented future deterioration.

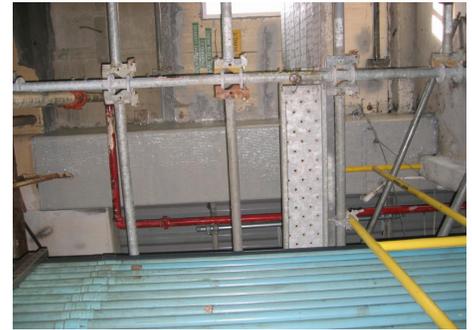
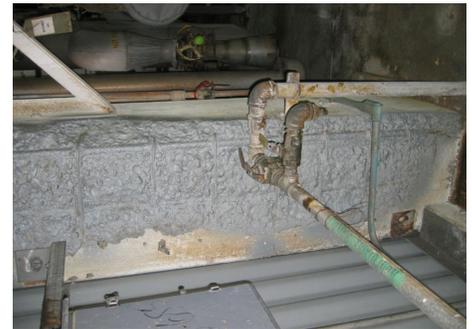
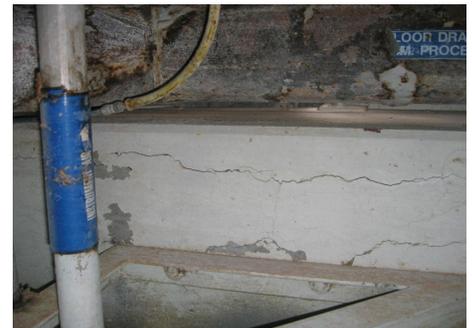
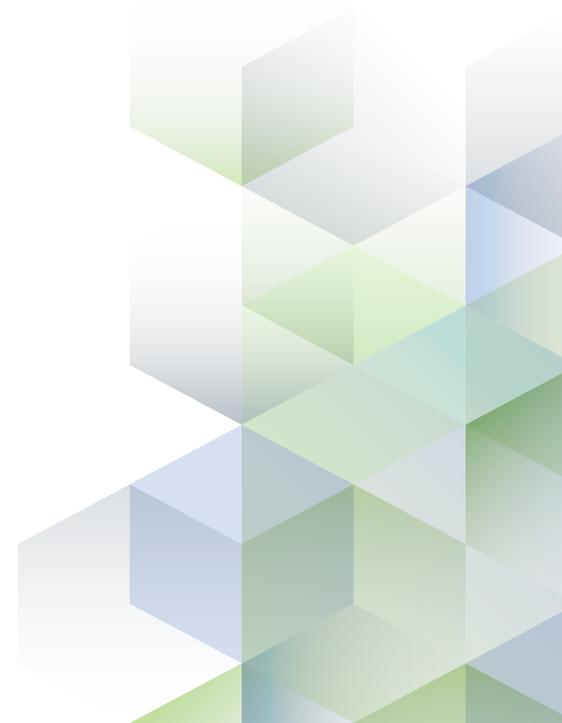
When a large pulp and paper manufacturer discovered damage to primary structural steel-reinforced columns, they called TEAM's concrete repair and polymer coating specialists for a safe and successful solution. Over time the contaminated water vapor from the paper production process had penetrated the concrete and corroded the reinforcing bars causing corrosion expansion and subsequent spalling of the concrete. Vibration in the structure due to the manufacturing process increased the rate of damage to the critical structural members.

Continued spalling of concrete and metal loss to the reinforcing bars would eventually lead to structural instability and building collapse. The customer required a repair that would improve integrity and prevent future degradation. Given the damage and active vibration the repairs were required on an urgent basis.

The repair involved removal of damaged material, surface preparation and priming of exposed steel and concrete, priming substrate, installation of stainless steel anchors across repair region, re-instatement of concrete using specialist repair mortar, surface preparation and priming of restored concrete and installation of specialist uni-directional carbon fiber reinforcement. The structure and repair area was coated with an impervious epoxy material to prevent further moisture ingress and to provide a professional finish.
