Nuclear Power Station Valve Repair

Repair of Damaged Valves at Nuclear Power Station

British Energy Torness Nuclear Power Station, Scotland

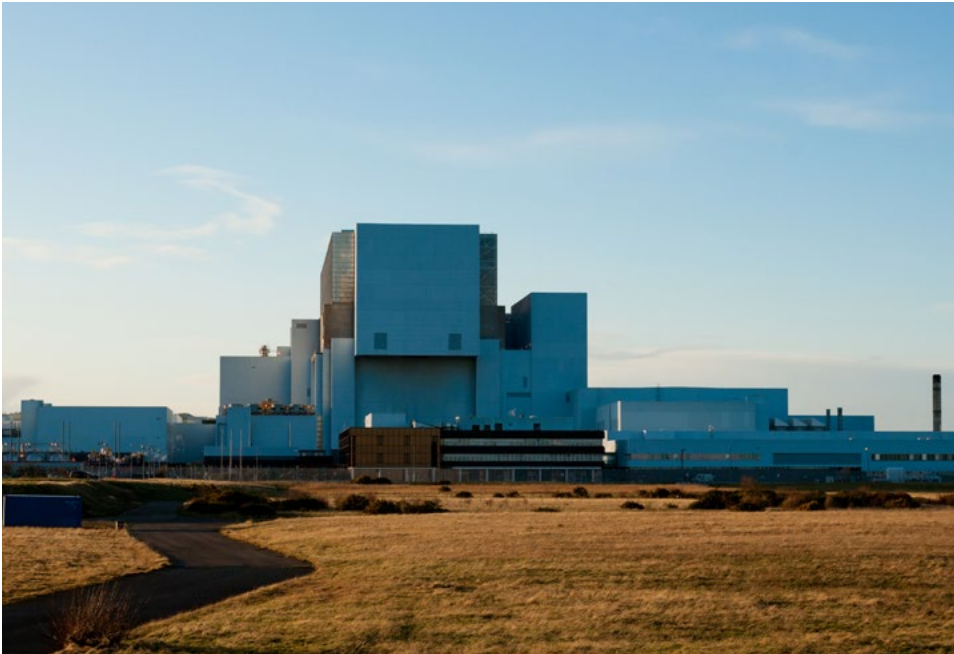
Damaged valves prevented standard isolation and replacement of large leaking bellows. TEAM designed, manufactured and installed a close-fitting bespoke encapsulation box as a solution.

The solution, a close-fitting bespoke encapsulation box, 2.7 metres in diameter was designed, manufactured and installed onto bellows fitted between two large valves which supply the main seawater cooling lines to the turbines.
