Concrete Column Repair Restores Integrity

Restoration of steel reinforced concrete columns

Concrete repair and polymer coating

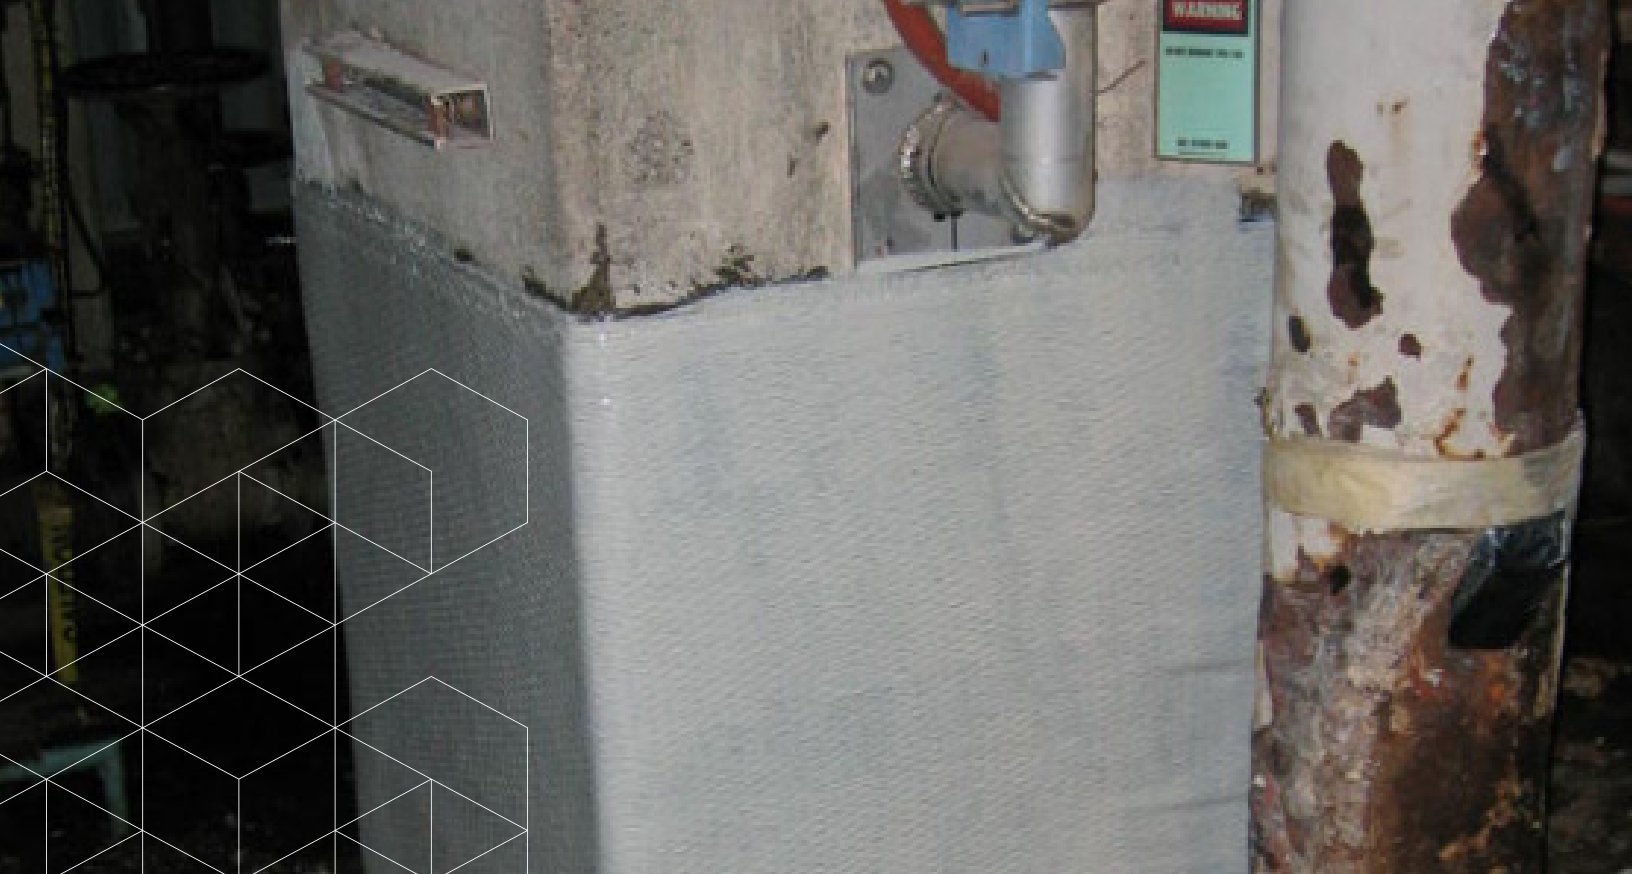
When a large pulp and paper facility discovered cracking in its primary structural columns they turned to TEAM for a quality solution to improve integrity, prevent future deterioration and provide a professional finish.

When a large pulp and paper manufacturer discovered damage to primary structural steel-reinforced columns, they called TEAM's concrete repair and polymer coating specialists for a safe and successful solution. Over time the contaminated water vapor from the paper production process had penetrated the concrete and corroded the reinforcing bars causing corrosion expansion and subsequent spalling of the concrete. Vibration in the structure due to the manufacturing process increased the rate of damage to the critical structural members.

Continued spalling of concrete and metal loss to the reinforcing bars would eventually lead to structural instability and building collapse. The customer required a repair that would improve integrity and prevent future degradation. Given the damage and active vibration the repairs were required on an urgent basis.

- Removal of loose concrete
- Priming of exposed repair surfaces
- Reinstatement of lost concrete with specialized repair mortar
- Overwrap of carbon fiber
- Epoxy top coat to seal repair and provide professional finish

The completed repair reinforced the structure and prevented future deterioration.

The repair involved removal of damaged material, surface preparation and priming of exposed steel and concrete, priming substrate, installation of stainless steel anchors across repair region, re-instatement of concrete using specialist repair mortar, surface preparation and priming of restored concrete and installation of specialist uni-directional carbon fiber reinforcement. The structure and repair area was coated with an impervious epoxy material to prevent further moisture ingress and to provide a professional finish.
