Remote Visual Inspection (RVI) Inspection Types

Quest Integrity provides a comprehensive range of Remote Visual Inspection (RVI) inspection types in order to reduce maintenance costs, avoid confined space entry and minimise shutdown time frames.

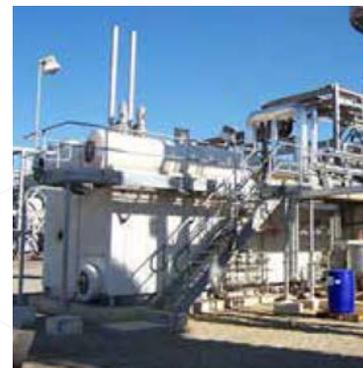
Water Tube Boiler

During a water tube boiler inspection, large amounts of deposition were found to be present throughout the unit. Fortunately this deposition was detected before serious corrosion and degradation had occurred. The risks of high deposition levels to asset reliability, efficiency, emission levels and life-span were discussed with the client. This information prompted modified boiler operation and enhancements to the water treatment programme.

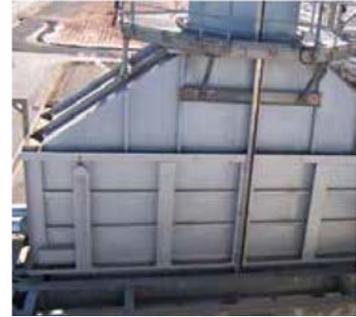
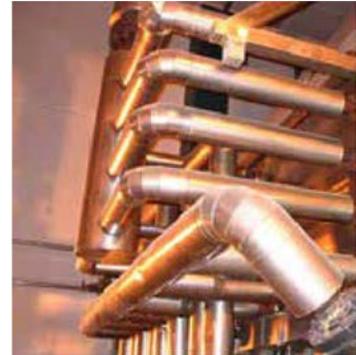
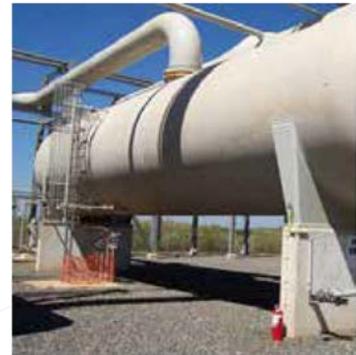
Pressure Vessels

The Quest RVI In-Spec programme was implemented across all plant vessels using our RVI specific ITPs and VAPs. Our review with the client revealed that 95% of the vessels were able to be inspected for GVI and CVI purposes and did not require a confined space entry to be performed. For those vessels that were selected for the application of RVI, strategically selected access points were chosen to ensure key target areas could be accessed to ensure the integrity of the inspection. These inspection points required minimal mechanical intervention, scaffolding, cranes and riggers. As there were no confined space entry elements and small diameter access points were used, a reduced level of isolations was required which further reduced the costs, personnel involved and the HSE risk profile.

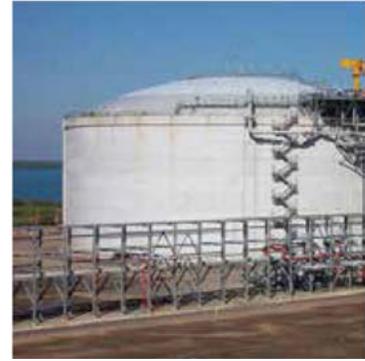
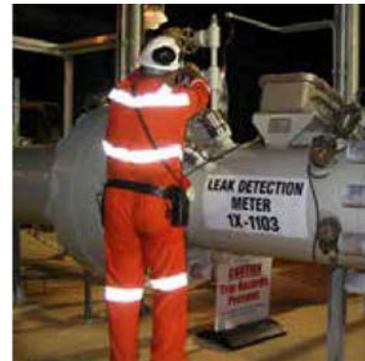
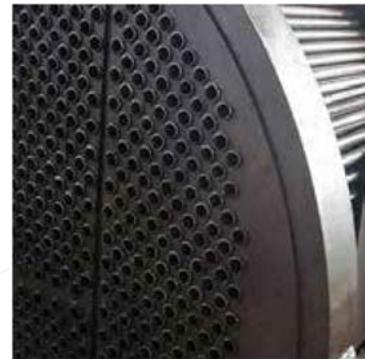
Heat Exchangers

A series of shell and tube heat exchangers were inspected using RVI techniques.

RVI inspection determined that all except one of the units were free from deposits and other issues relating to the integrity and efficiency of the tube bundle. For the one tube bundle that required further cleaning, the head was removed, the tubes cleaned and re-inspected to ascertain the effectiveness of the clean, and the head re-instated.

RVI inspection determined the internal condition of the vessel and tube bundle without removal of the bundle.

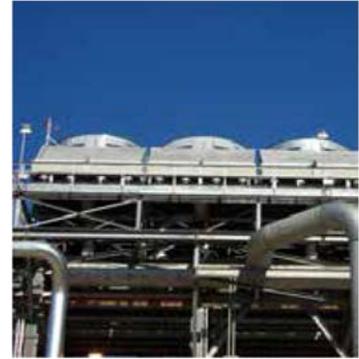
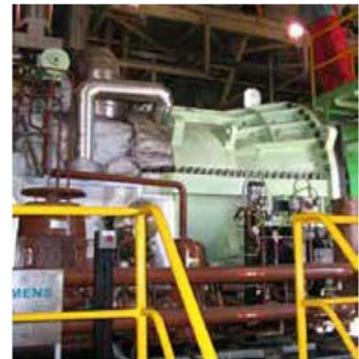
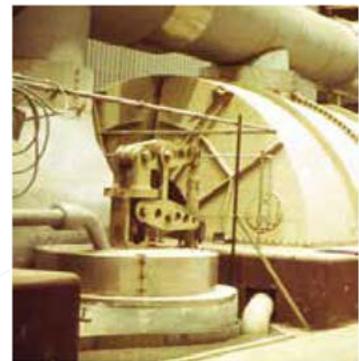
Steam Turbines

The turbine was inspected using our umbilical heat exchanger (cooling jacket). The unit was still reading 240° Celsius at the time of the inspection. We detected fouling on the LP side of the Stage 2 blades along with indications of deposition passing through the HP gland seal system. This continued build up of these deposits and the premature wear they create on gland seal systems would have resulted in further decreased performance and more extensive repairs. Early detection proved to be invaluable to the client.

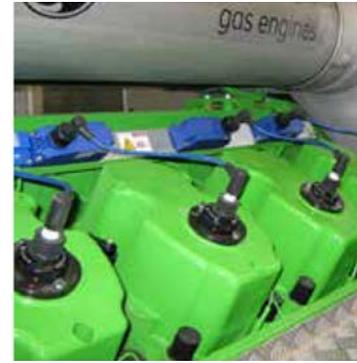
Engines

The inspection revealed early indications of the exhaust valve seat burning. This information prompted the client to instigate replacement valves immediately and better tune the air/fuel ratio to prevent further damage to other cylinder heads. The client was delighted that the findings had saved the need for a full head reconditioning.

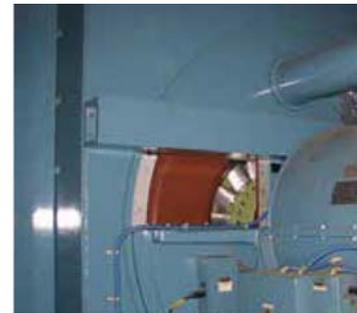
Generators

Inspection of a generator used in the geothermal industry revealed a particular type of corrosion associated with hydrogen sulphide. Early detection enabled the client to install filter/scrubber systems on the generator's cooling ducts. As we were able to fully ascertain the extent of the corrosion, the client also organised a replacement unit to be built and installed at a later date.

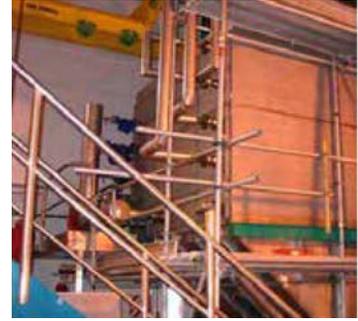
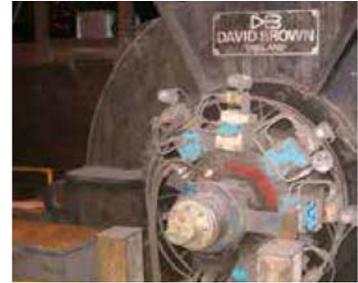
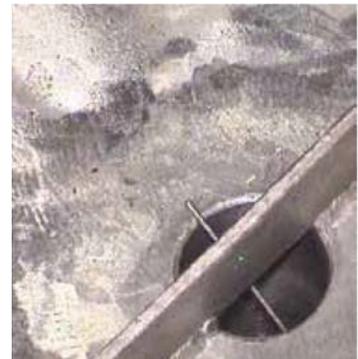
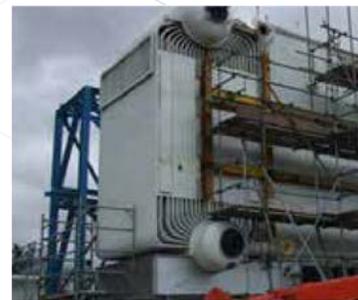
A main steam feed line connected to eight different process plants was inspected. Inspection revealed isolated areas of corrosion in the steam lines. The client was able to investigate and determine that the root cause of the corrosion was a chemical used in the steam generation process. A chemical substitute was found and used.
