Gas Leakage Find and Fix Utilizing Optical Gas Imaging & Leak Repair

Combining optical gas imaging with on-line leak repair to discover, quantify then repair invisible gas leaks

Optical gas imaging & leak repair

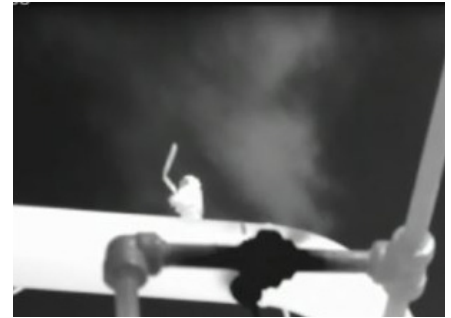
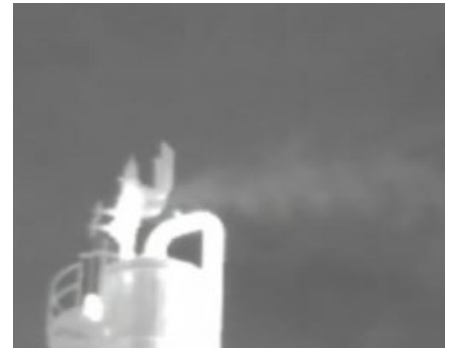
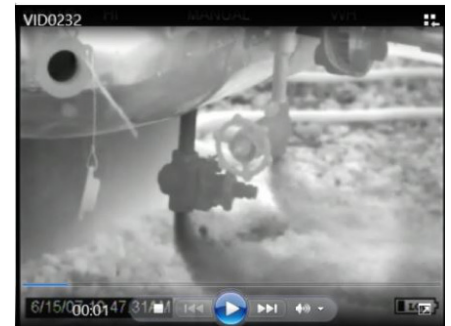
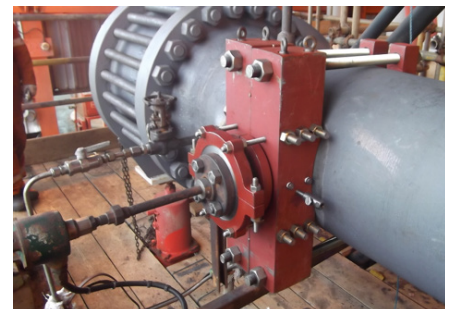
Invisible gas leaks were safely and effectively eliminated using advanced optical gas imaging (OGI) cameras to discover and quantify the leaks and best-in-class on-stream leak repair technology to seal them.

Optical gas imaging (OGI) cameras can detect methane, sulfur hexafluoride, and hundreds of other industrial gases quickly, accurately, and safely—without shutting down systems. With OGI cameras, TEAM can scan broad sections of equipment rapidly and survey areas that are hard to reach with traditional contact measurement tools. OGI cameras can also detect leaks from a safe distance, displaying these invisible gases as clouds of smoke.

When leaks are identified using the OGI camera, a TEAM technician (where possible) takes a direct measurement of the leak concentration (in PPM) at the point of leakage. This provides a figure against which to prioritize and measure the effectiveness of repair efforts.

On-Stream leak repair technology allows leaks to be sealed while equipment is in-service. This eliminates asset downtime and restores pressure integrity. Leaks can be sealed on a wide range of pressurized system components such as flanges, valve stems, piping, vessels and tanks.
